Coastal Erosion Management Options

Cowes Main Beach Foreshore Reserve

Bass Coastal Shire Council

April 2018

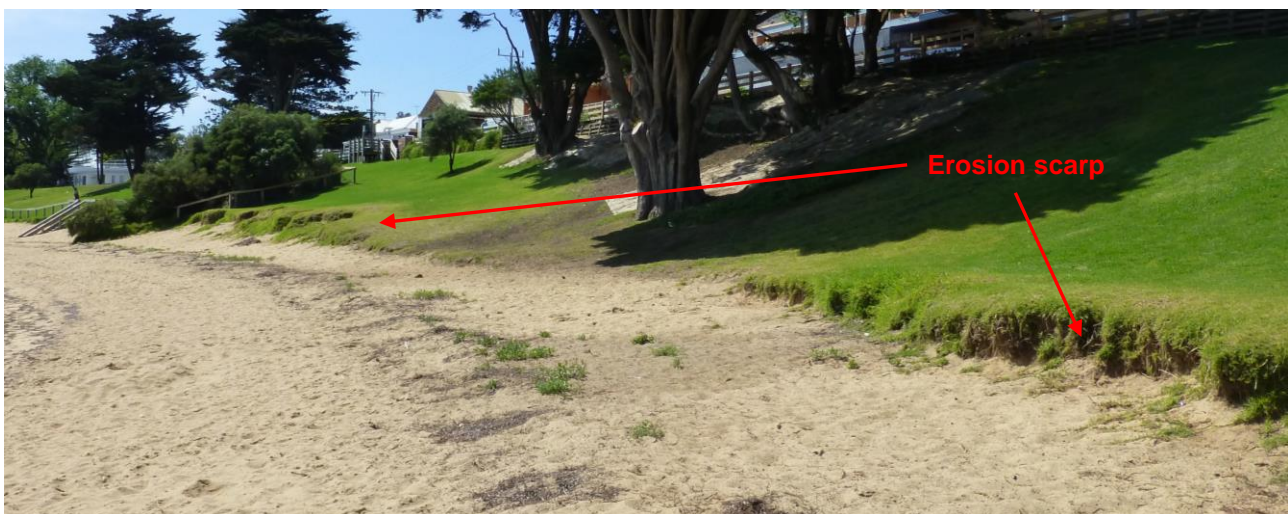
Figure 2-1 Erosion scarp at beach interface with foreshore reserve

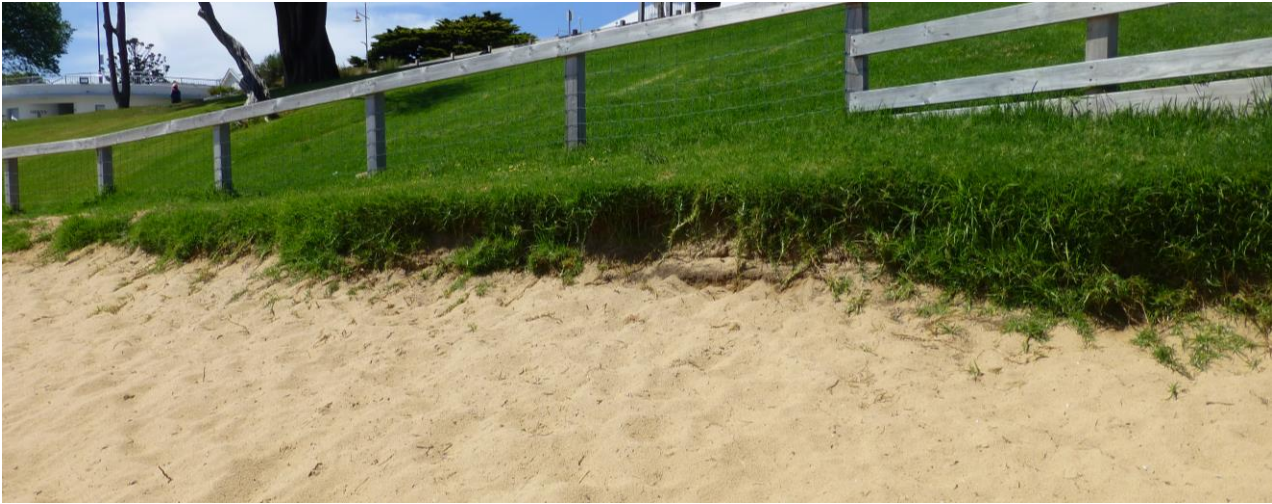
Figure 2-2 Erosion scarp at beach interface with foreshore reserve

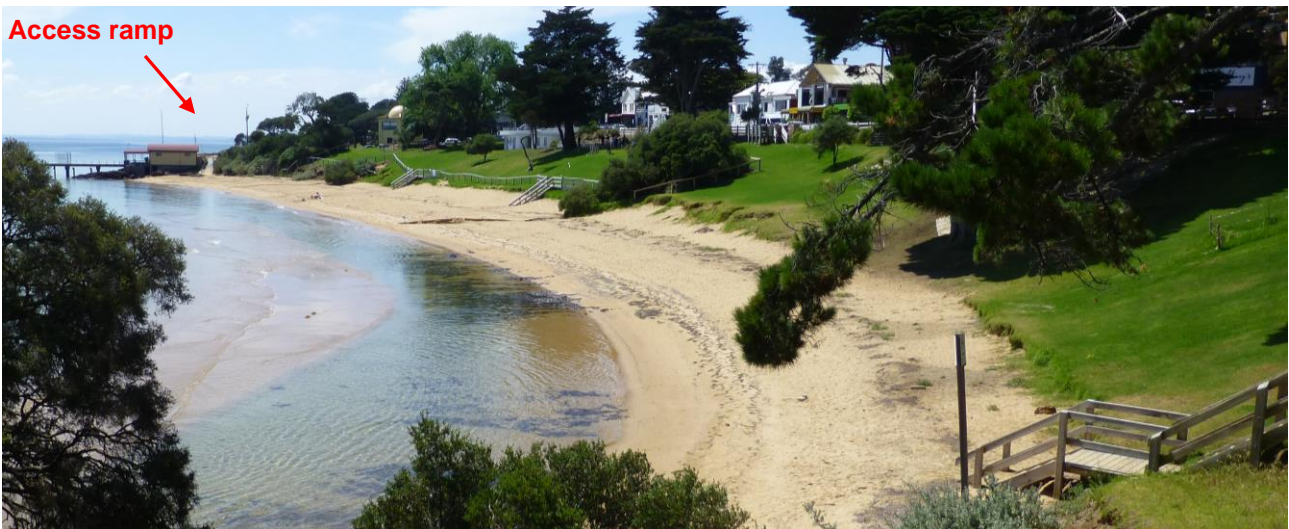
Figure 2-3 Beach access points (stairs, dune and ramp (far end of beach))

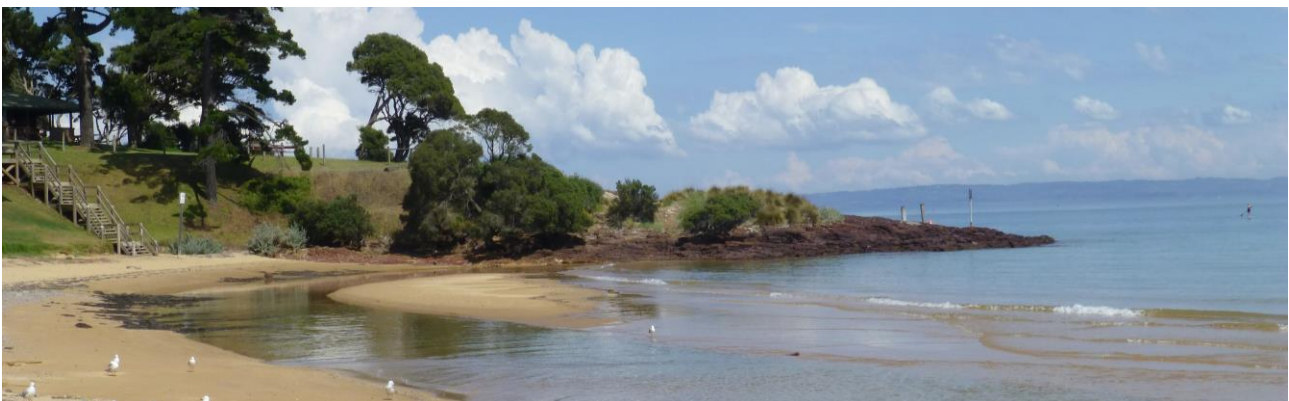
Figure 2-4 Rocky outcrop at the western end of Cowes main beach

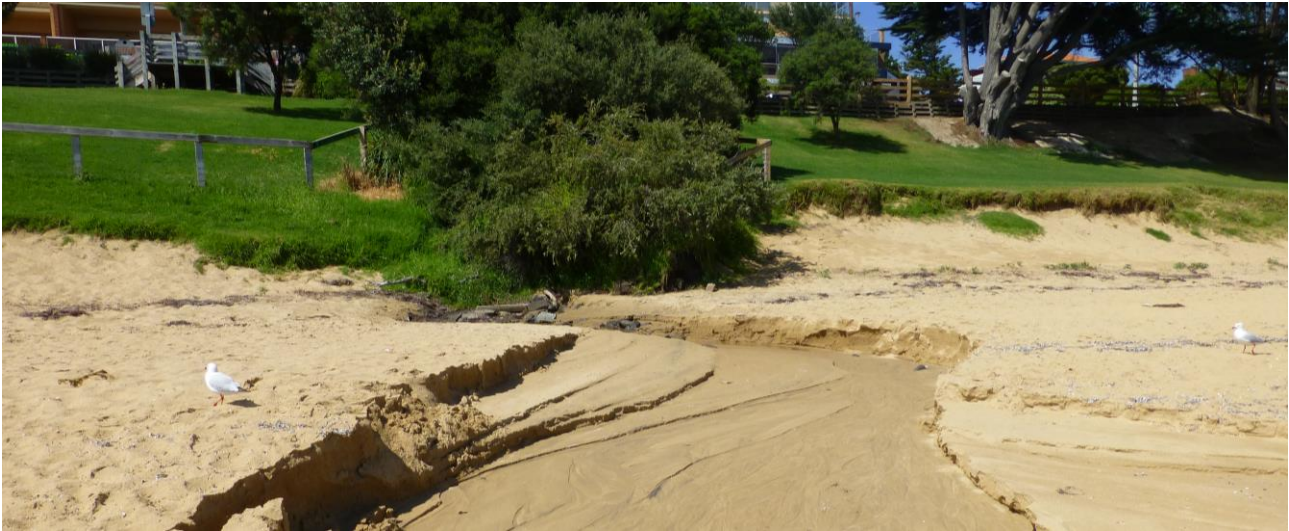
Figure 2-5 Storm water outfall located on Cowes main beach.

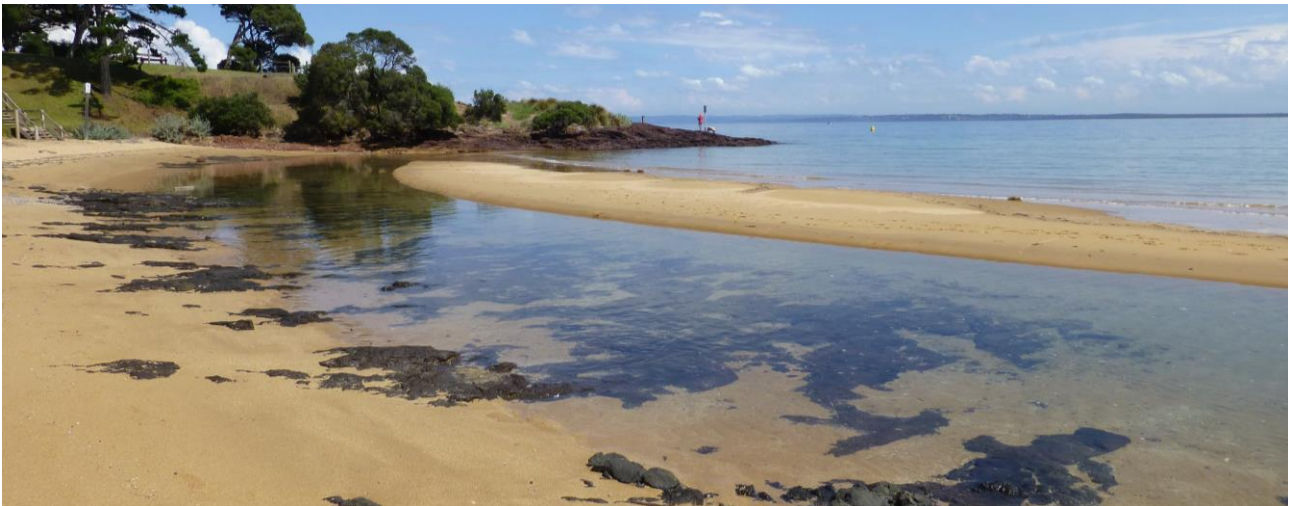
Figure 2-6 Rocky / reef substrate on Cowes main beach.

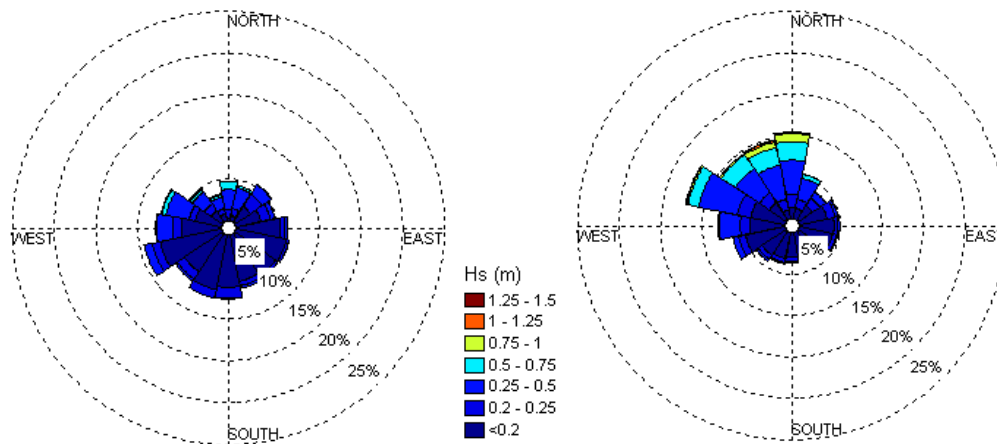
Figure 4-1 Wave Roses – Summer (2003) & Winter (2003) (Water Technology, 2014)

The waves experienced at Coves are predominantly locally generated within the eastern and western arms of Western Port. Predicted wave roses in the vicinity of the study area as part of the 2014 Western Port Coastal Hazard Assessment undertaken by Water Technology are presented in Figure 4-1 by season. Waves are observed to vary with seasonal wind climate, such that the majority of waves arrive from the northwest in winter. Due to the study area’s northerly aspect, waves are generally very small in the summer months, coinciding with the timeframe when strong winds are from the southwest to southeast.

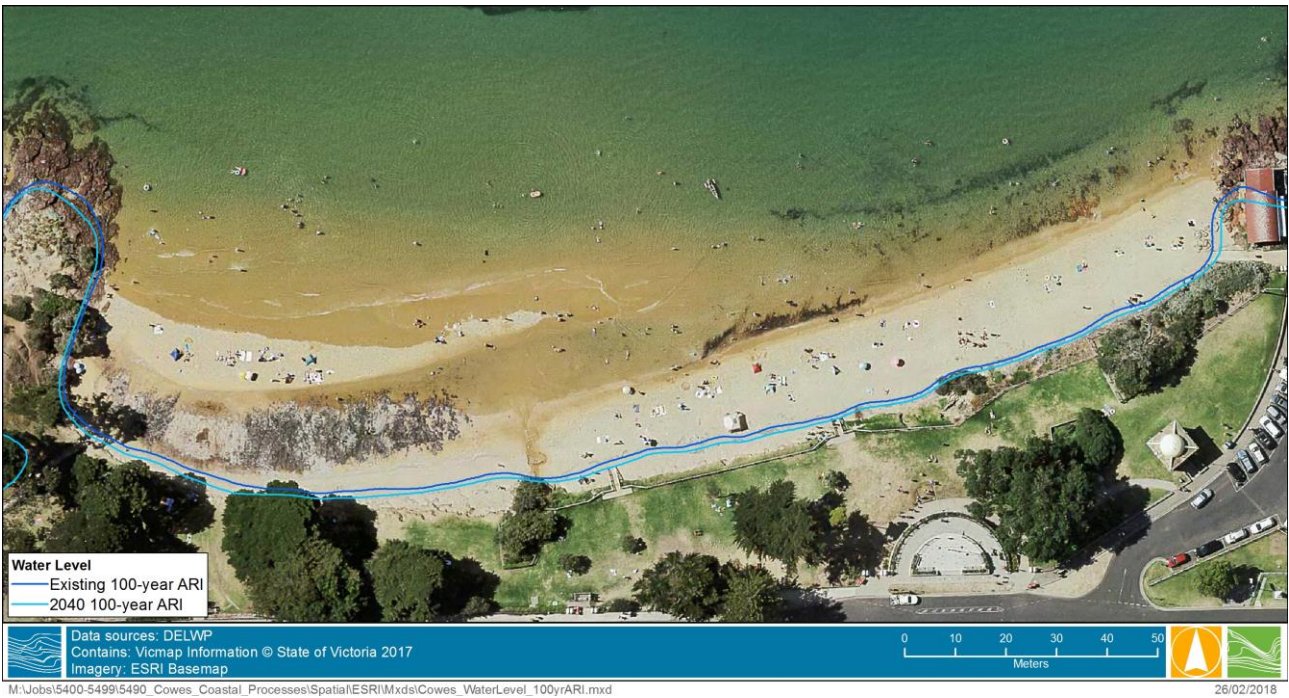
Figure 4-2 Extent of 100-year ARI water levels on the site for present day and 2040

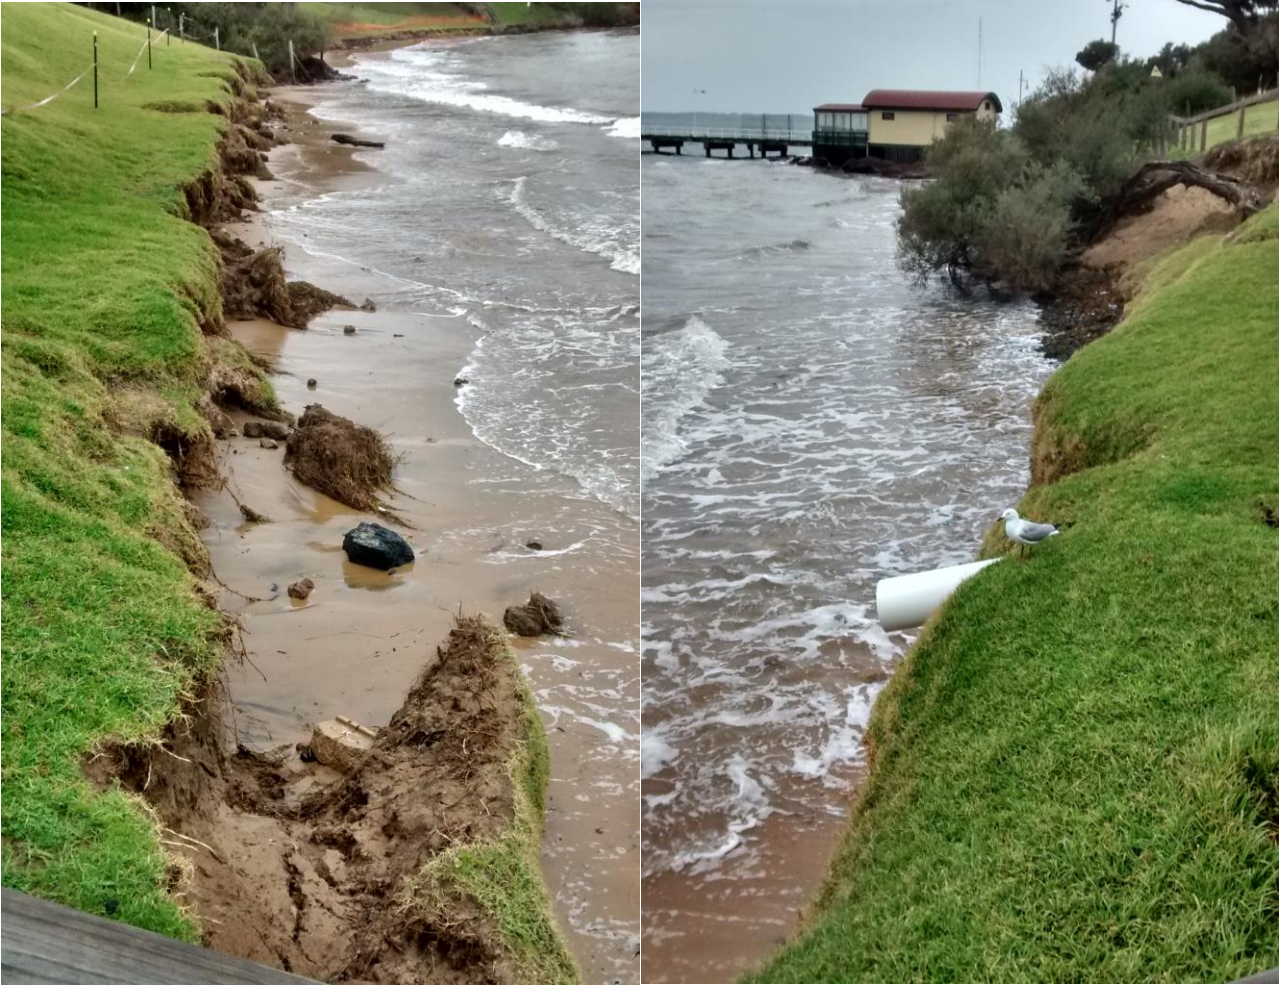
Figure 4-5 Storm action leading to erosion, 22nd July 2016 (Bass Coast Shire Council)

Though the water levels do not reach the base of the scarp, as highlighted within Figure 4-3 and Figure 4-4, the water levels provided do not take into consideration wave set up and run up. Wave set up and run up can have a large impact on the scarp erosion observed between the sandy beach face and the vegetated foredune. The vegetation located on the eastern section of the beach is providing some stability to the scarp in this section, which limits the erosion during high water level events. As observed in Figure 4-5, water levels acted on the base of the scarp during the July 2016 storm.

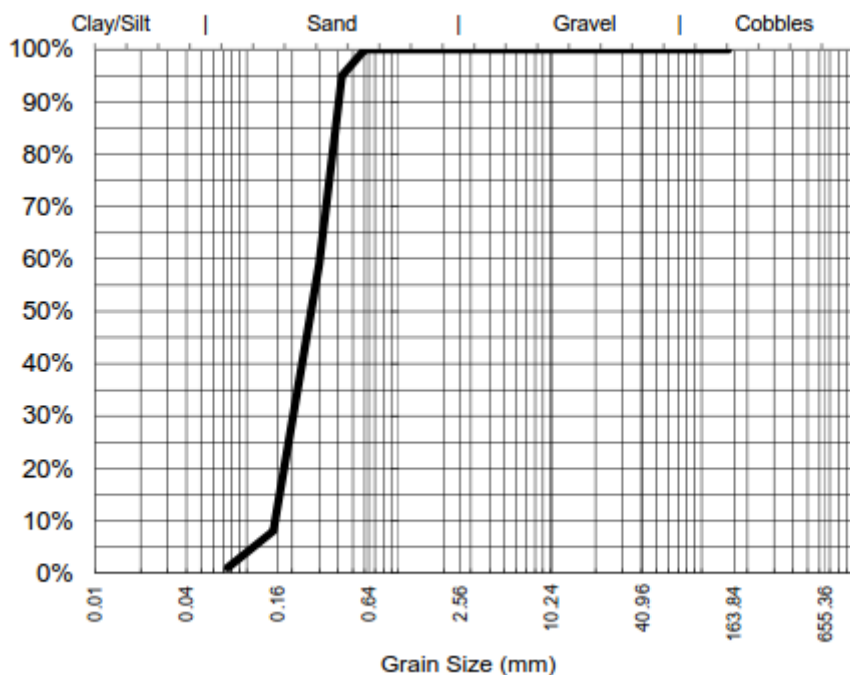
Figure 5-1 Coves Beach Particle Size Distribution

A sediment sample was taken from the beach face in the upper intertidal zone during the site visit. Particle size analysis was undertaken by ALS Environmental; a summary of the results can be found within Table 5-1 and Figure 5-1. The sediment had a median particle size of 0.274mm, characterising it as medium sand.

Particle Size (mm)	Percentage Passing
0.600	100%
0.425	95%
0.300	59%
0.150	8%
0.75	1%

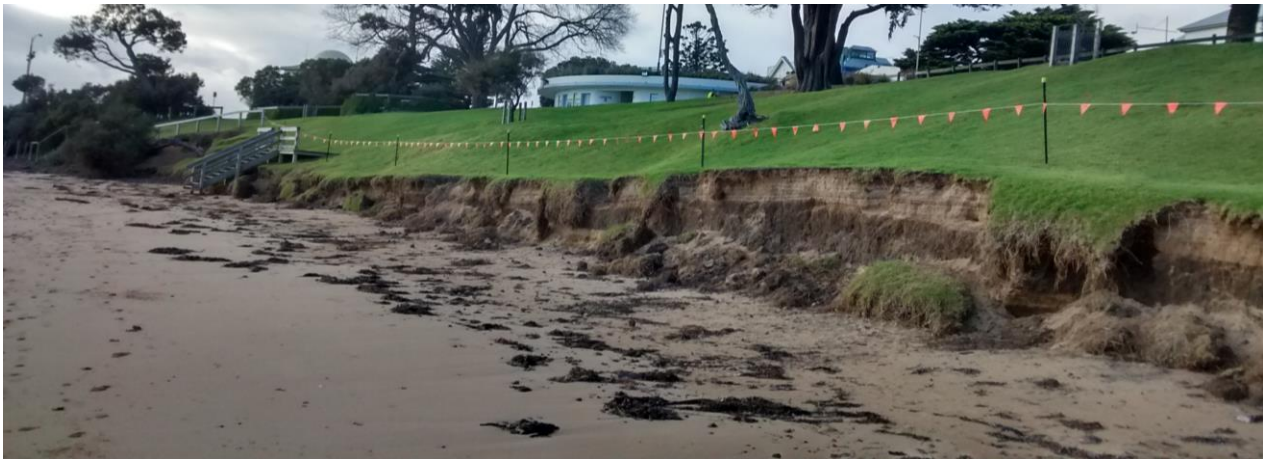
Figure 5-3 Cowes Main Beach Erosion Scarp 3/08/2016 (Bass Coast Shire Council)

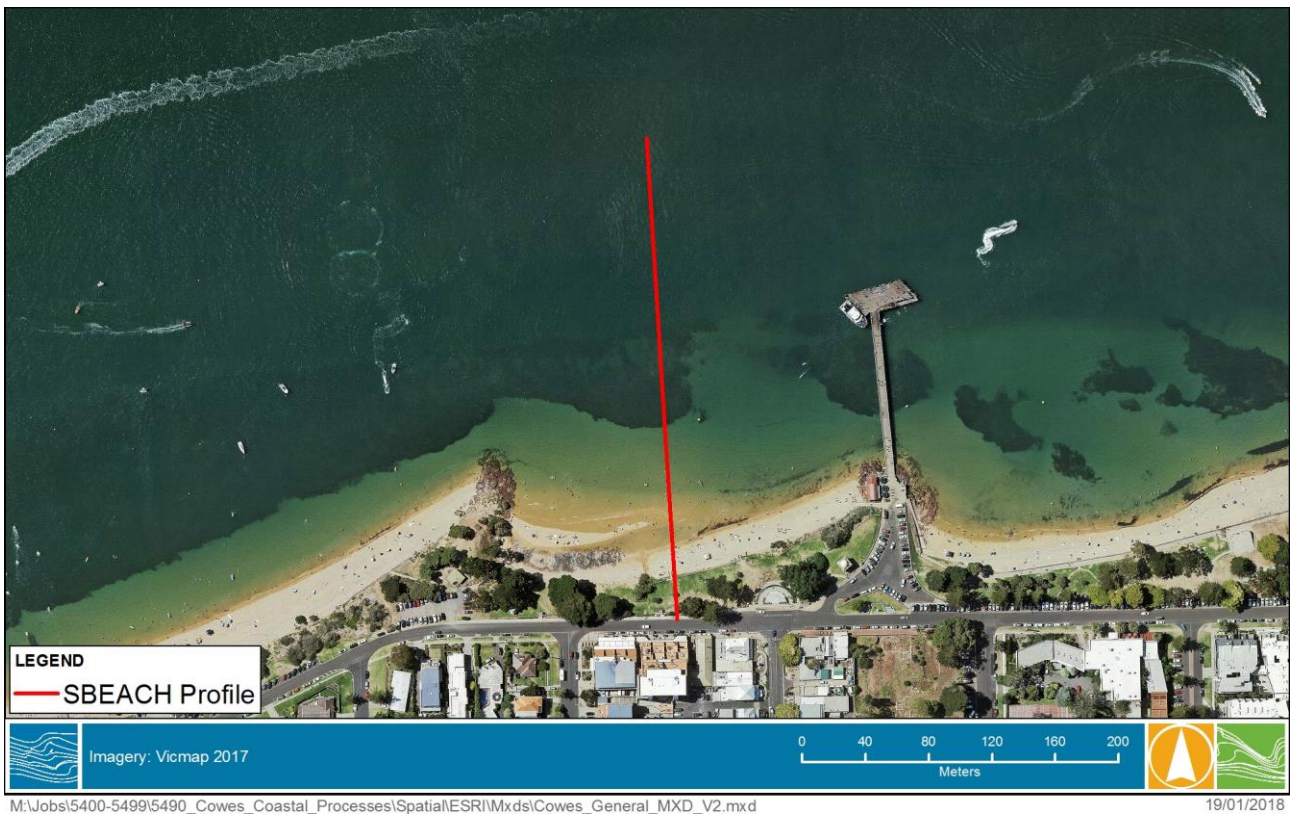
Figure 5-6 SBEACH Profile Location

A cross-shore profile was extracted from the beach survey data, LiDAR and coastal DEM (refer Section 3). The profile extends landward to The Esplanade, which is located at an elevation of 10 m AHD, and offshore to a depth of -8 m AHD (see Figure 5-6). By extending to -8 m AHD, this ensured that the depth of closure (limit of cross-shore sediment transport) is captured within the profile. The results of the 10, 20, 50 and 100-year ARI events for this profile can be found within Figure 5-7. A more detailed view of the main erosion zone seen in Figure 5-8. This is simply a zoomed-in view of Figure 5-7, chainages 30 to 60.

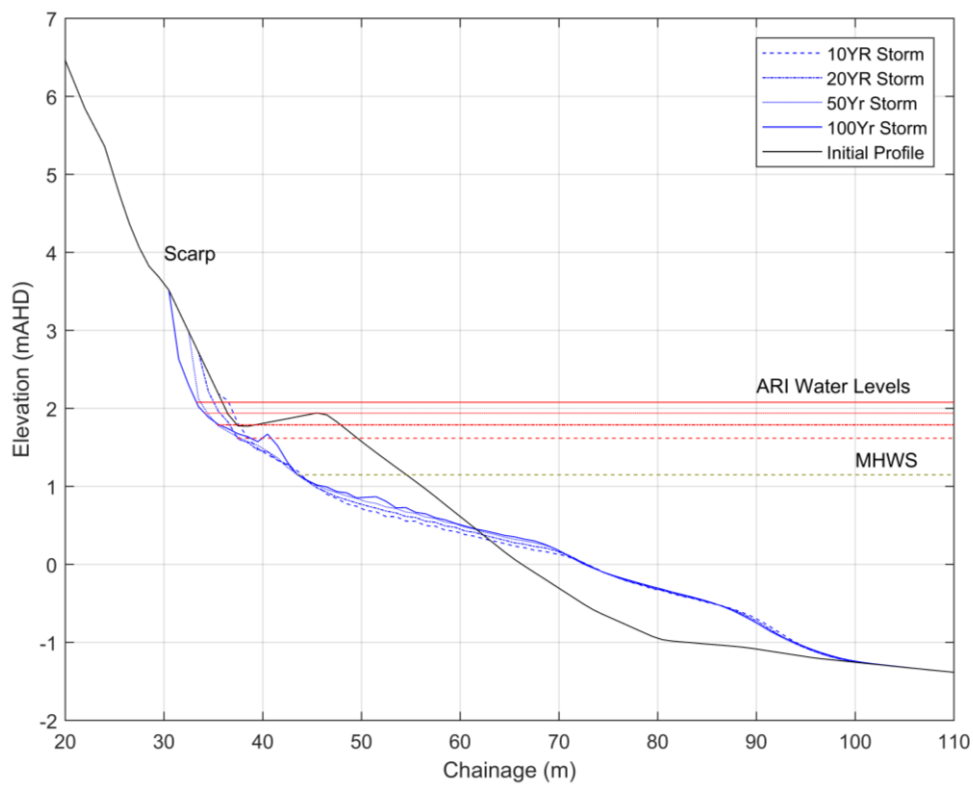
Figure 5-7 SBEACH results

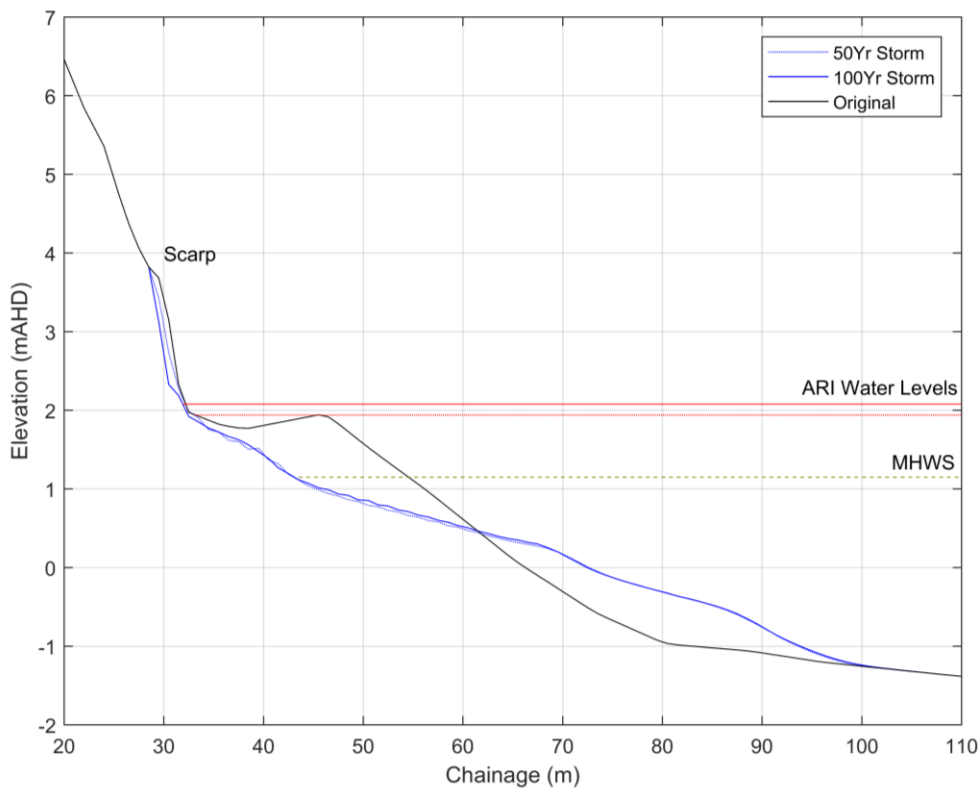
Figure 5-9 SBEACH results - adjusted profile

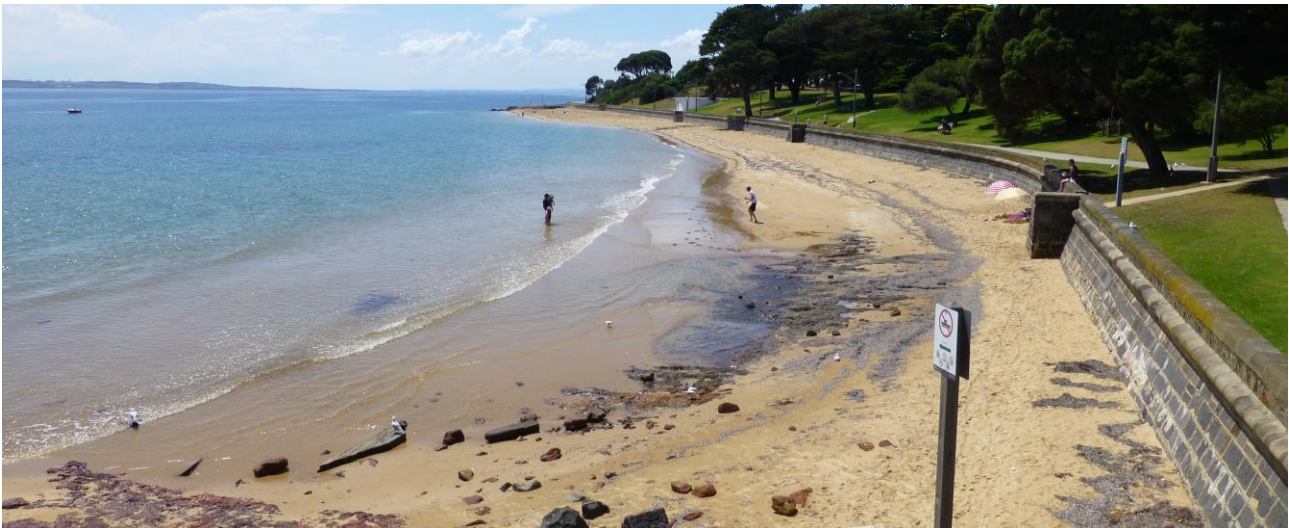
Figure 6-2 Cowes East Beach at time of site visit – 17th November 2017

An example of a vertical seawall is observed immediately to the east of the study area, at Cowes East. This beach is lined along its length with a vertical masonry wall. This beach is narrower than the Cowes Main Beach, as indicated by the aerial image dated 31st July 2016 extracted from Google Earth (Figure 6-1). At the high-water mark in this image the beach is almost non-existent. Comparatively, a wider beach was present during the 17th November 2017 site visit, as shown in Figure 6-2. However, this is still narrower than the observed beach at Cowes Main Beach (refer Section 2). Whilst there are many factors that could contribute to the beach width, the presence of the seawall is likely a contributing factor as there is no sediment buffer available to mitigate the impacts of cross-shore erosion. In addition, the vertical wall results in wave reflection which introduces increased turbidity and erosion at the toe of the seawall – exacerbating the movement of sand offshore.

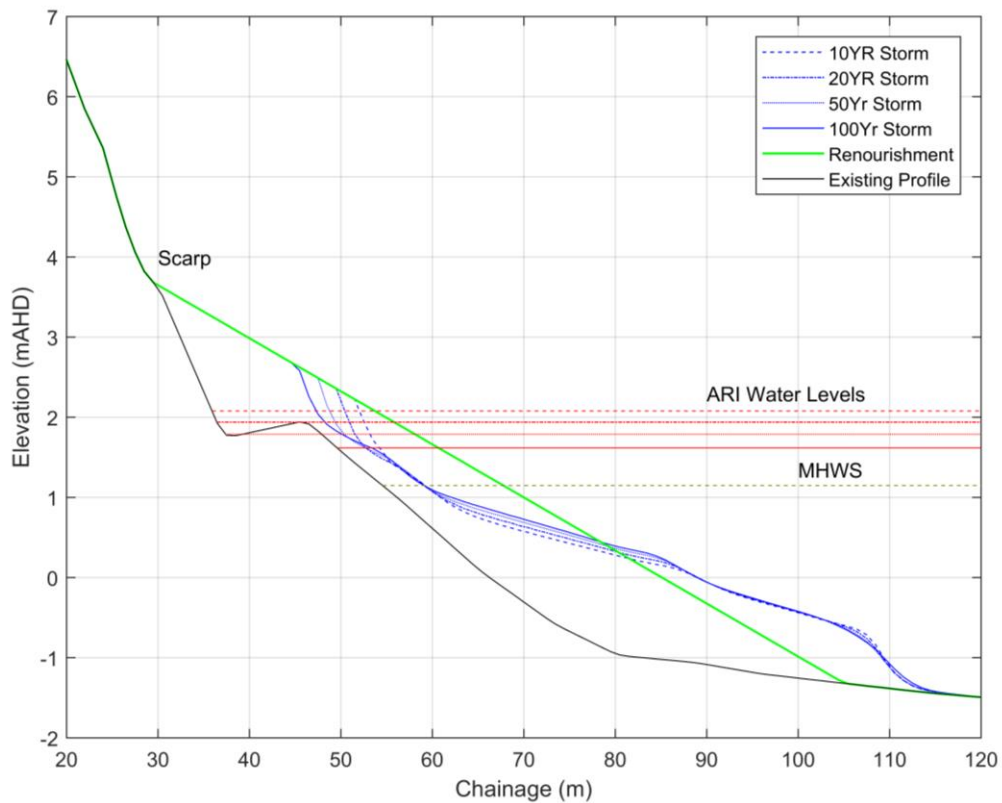
Figure 7-4 SBEACH: Renourishment Option 2

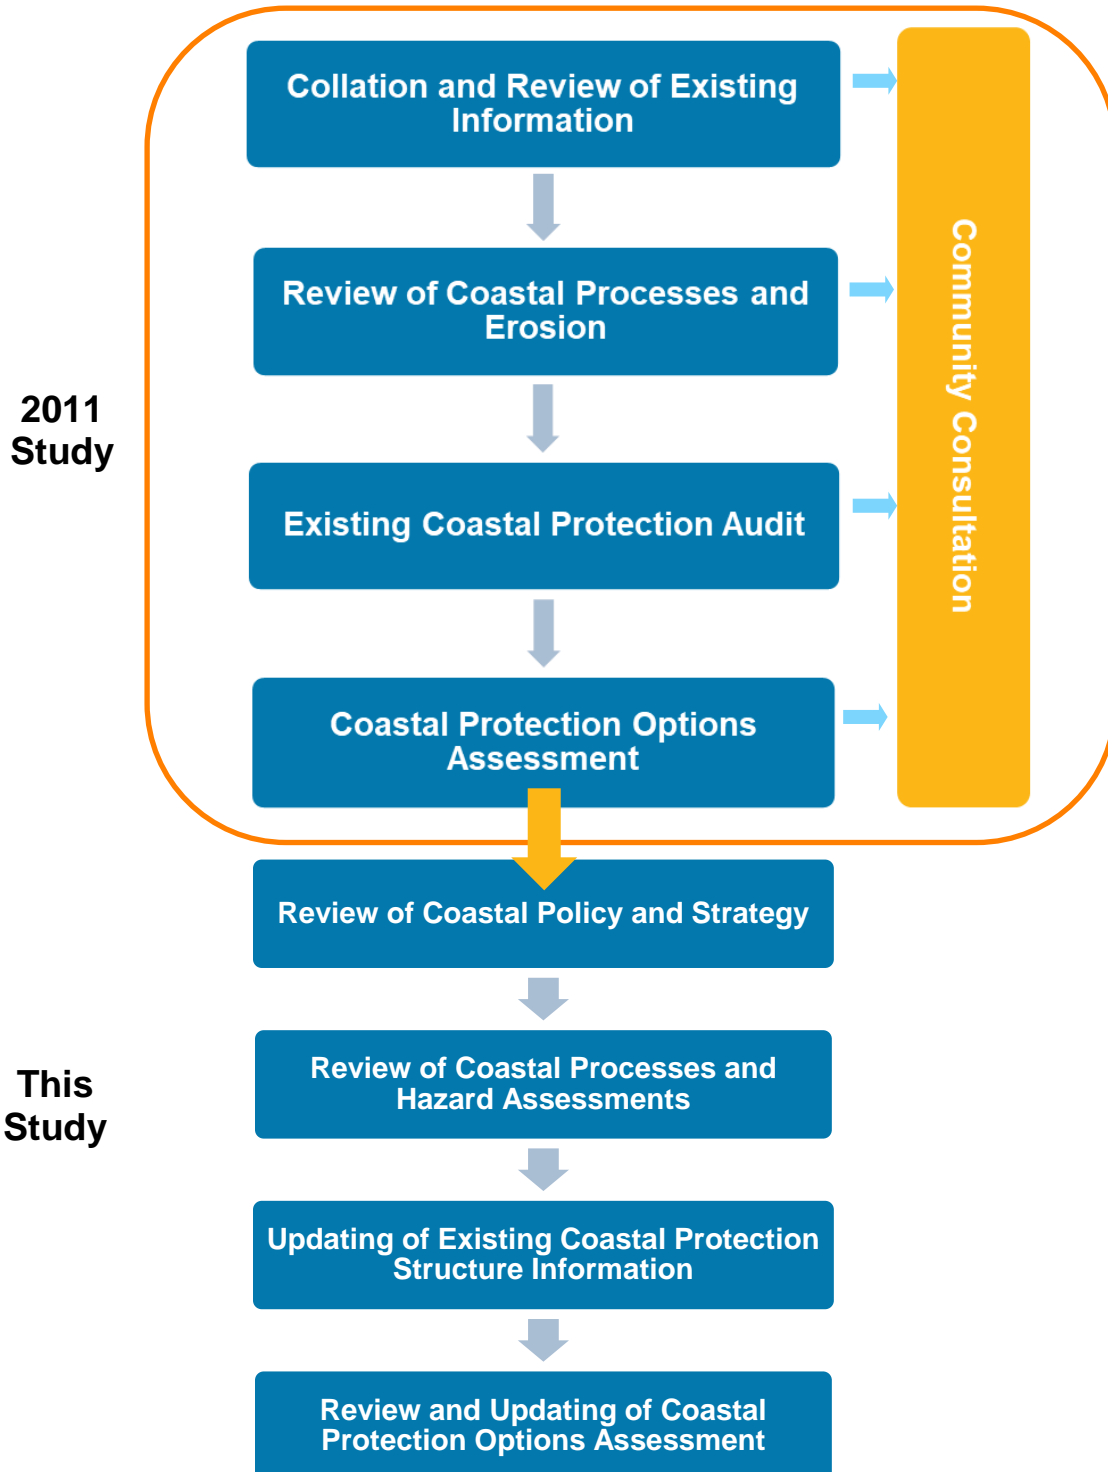
FIGURE 3-1 PROJECT METHODOLOGY

The methodology outlined in Figure 3-1 has been undertaken to investigate the causes of the existing shoreline erosion and inundation hazards on the study area and to explore management options to mitigate these hazards. This combined the work detailed in the previous 2011 study report along with the review and updates for the present study.

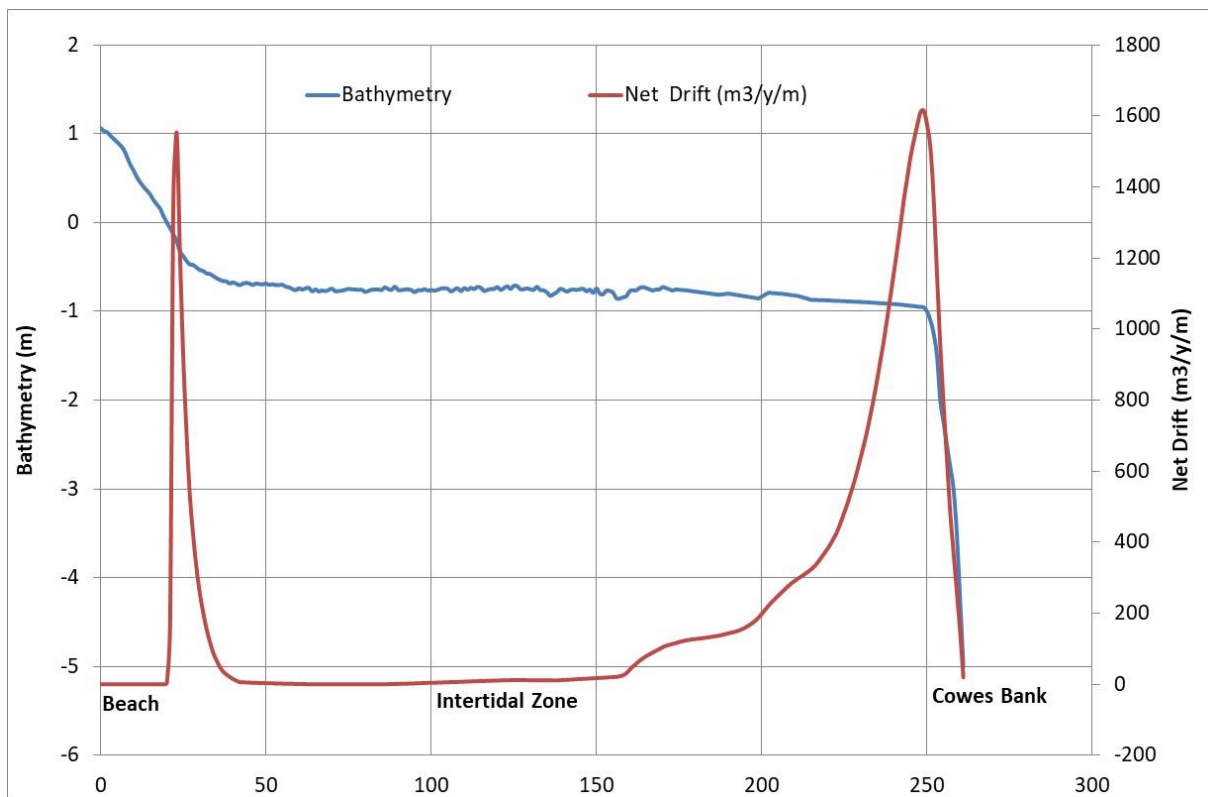
FIGURE 5-5 POTENTIAL ANNUAL NET EASTWARD LONGSHORE SEDIMENT TRANSPORT DISTRIBUTION

- Overall rates of potential sediment transport are relatively small, this reflects the sheltered northerly aspect and resulting mild wave climate that exists to transport sediment along the coastline.
- The large majority of the sediment transport is predicted to occur offshore on the seaward edge of Cowes Bank. This is where the largest waves break, and only smaller waves are able to propagate across Cowes Bank and onto the shoreline at high tides, resulting in lower potential for sediment transport on the shoreline.
- The magnitude of the annual rate of longshore sediment transport on the shoreline is particularly small however, during the combination of a large storm surge and wave event on the coastline, significant quantities of sediment can be transported over short periods along the shoreline.

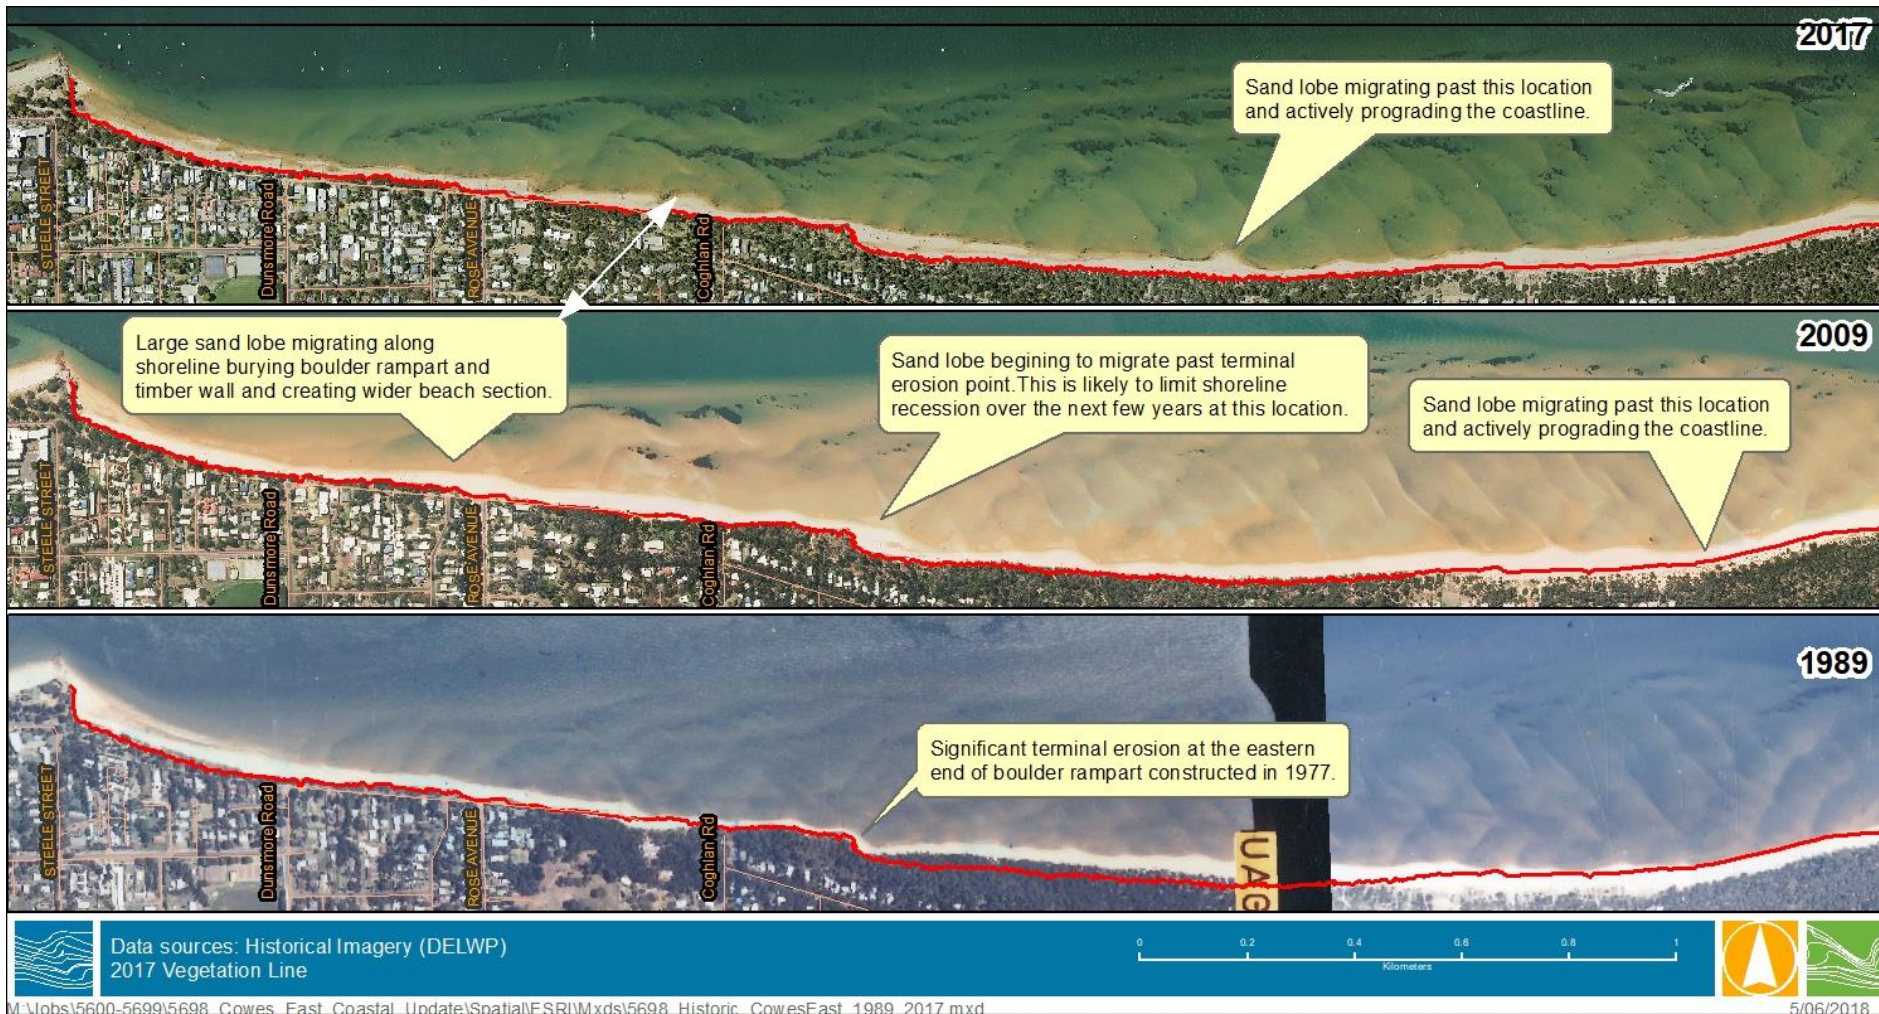
FIGURE 5-6 HISTORICAL SHORELINE CHANGE (1989-2017)

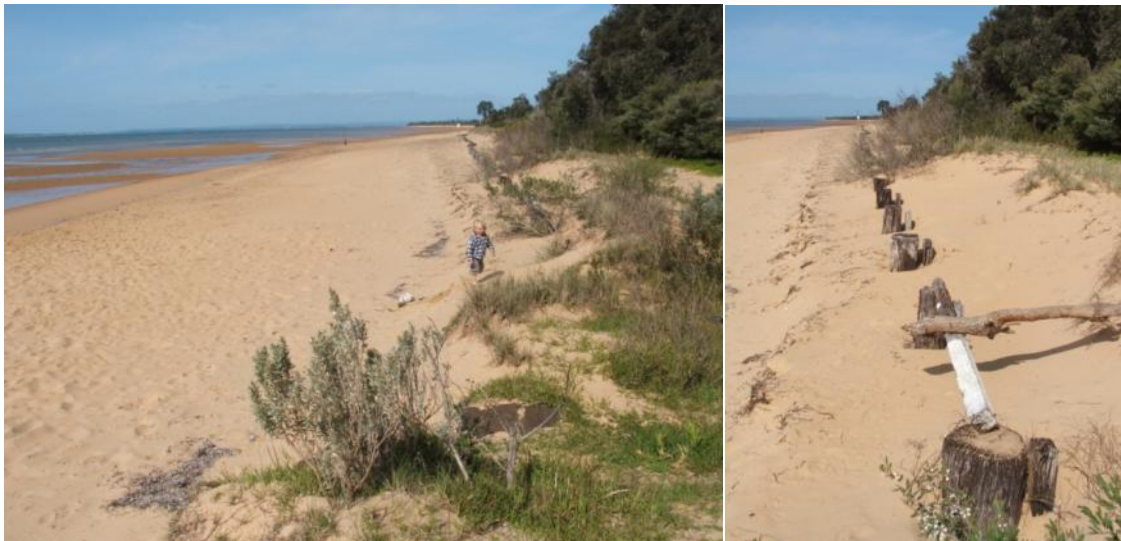
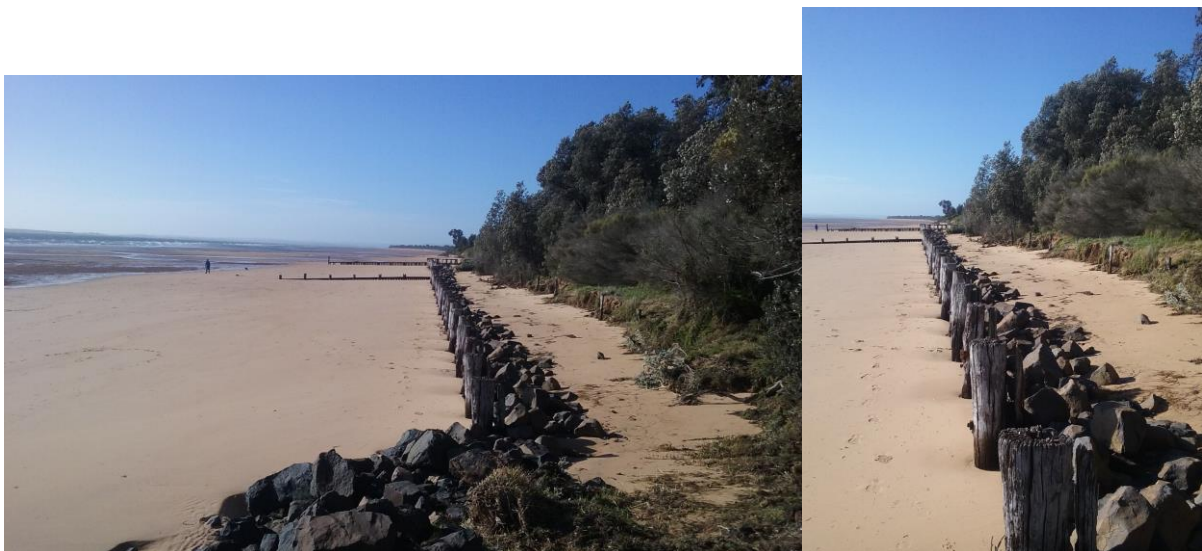
FIGURE 5-10 TIMBER WALL EAST OF ROSE AVENUE 1986 (TOP), 2010 (MIDDLE), 2018 (BOTTOM)

Figure 5-10 shows the extent of accretion that occurred in the vicinity of the timber wall between the mid-1980s and 2010 along this section of shoreline. The eastward migration of a broad sand lobe in this section of the beach resulted in a slight decrease in beach width by 2017 and in the 2018 photo there has clearly been a reduction in beach volume with increasing exposure of the timber wall and associated rock work.

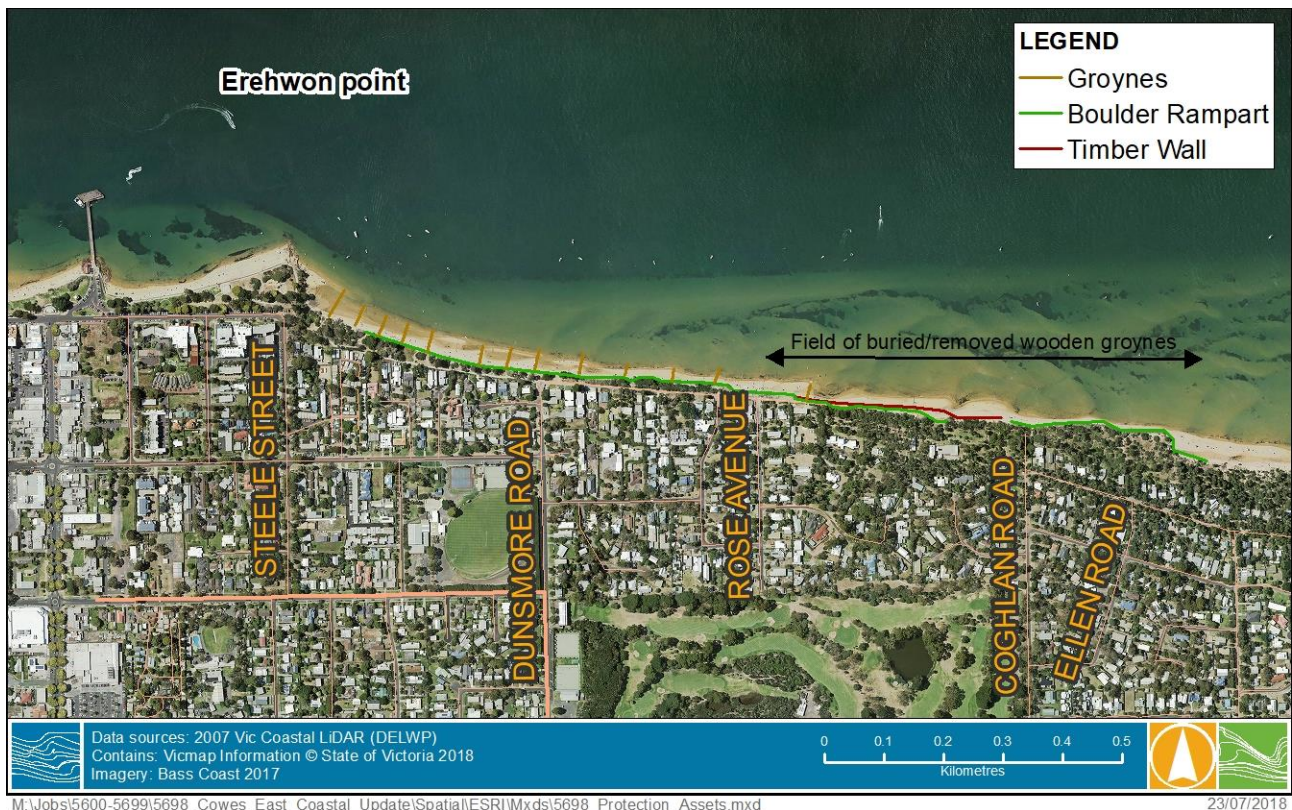
FIGURE 6-1 EXISTING COASTAL PROTECTION ASSETS

Figure 6-1 below displays the location and extent of the three main coastal protection assets along the study area coastline. The following sections summarises the condition and an assessment of the effectiveness of the existing shore protection assets. Seven wooden groynes located west of Broughton Ave have been installed or replaced by Department of Environment Land Water Planning (DELWP) since the 2011 report.

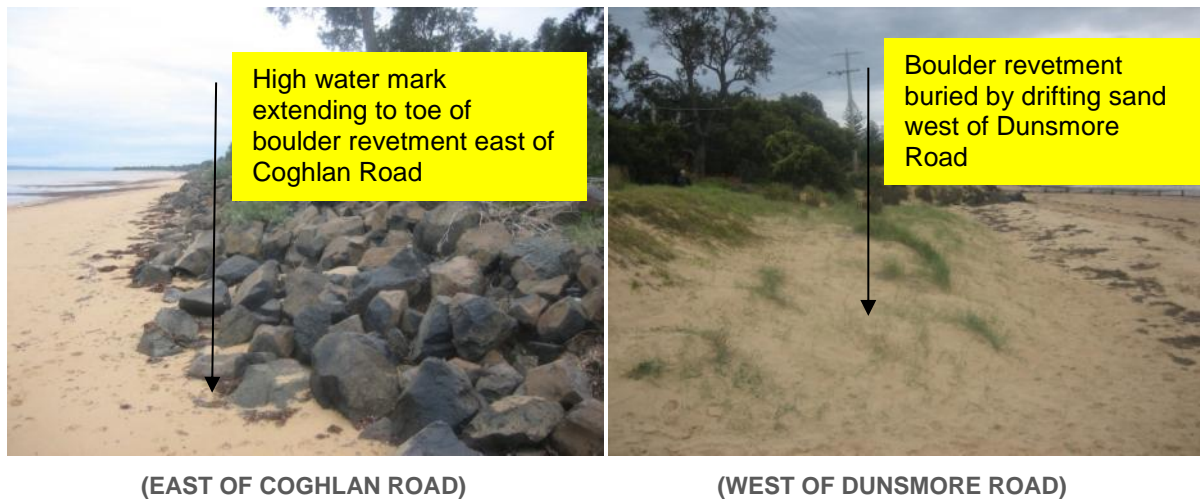
FIGURE 6-4 BOULDER REVETMENTS ALONG STUDY AREA FORESHORE (AUGUST 2010)

At the time of the 2011 study, the boulder revetments along many sections of the study area were fronted by a prograding beach and were partially buried by sand which had been colonised by vegetation, Figure 6-4. However, since 2011 storm events have continued to erode the beach areas in front of the revetments, exposing more of the structures. Where exposed, rock revetments have a tendency to flatten and lower the beach profile.

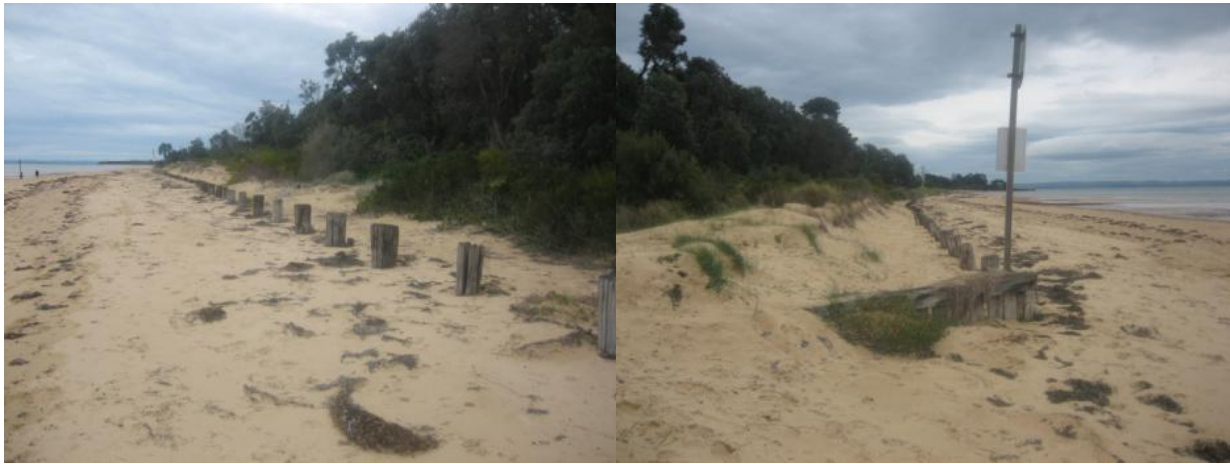
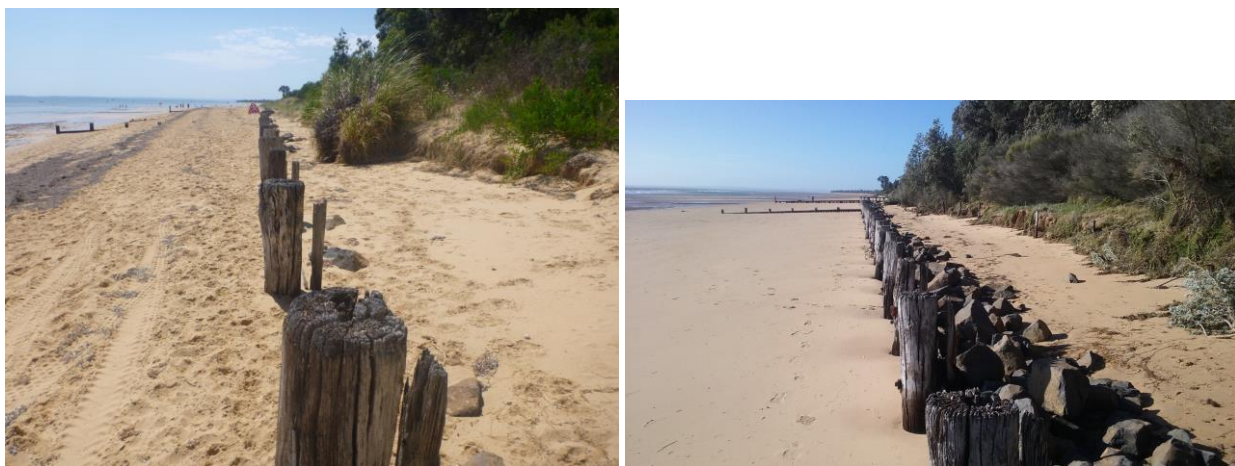
FIGURE 6-5 TIMBER WALLS BETWEEN ROSE AVENUE AND COGHLAN ROAD (2010 – 2018)

Storm events during 2012/13 resulted in erosion of sand and increased the exposure of the upper part of the structure as shown in the 2014 photo, Figure 6-6. The 2018 image shows that this trend has continued, with increased shoreward extent of the erosion as well as an overall lowering of the beach level
