Coastal Erosion Management Options

Cowes Main Beach Foreshore Reserve

Bass Coastal Shire Council

April 2018

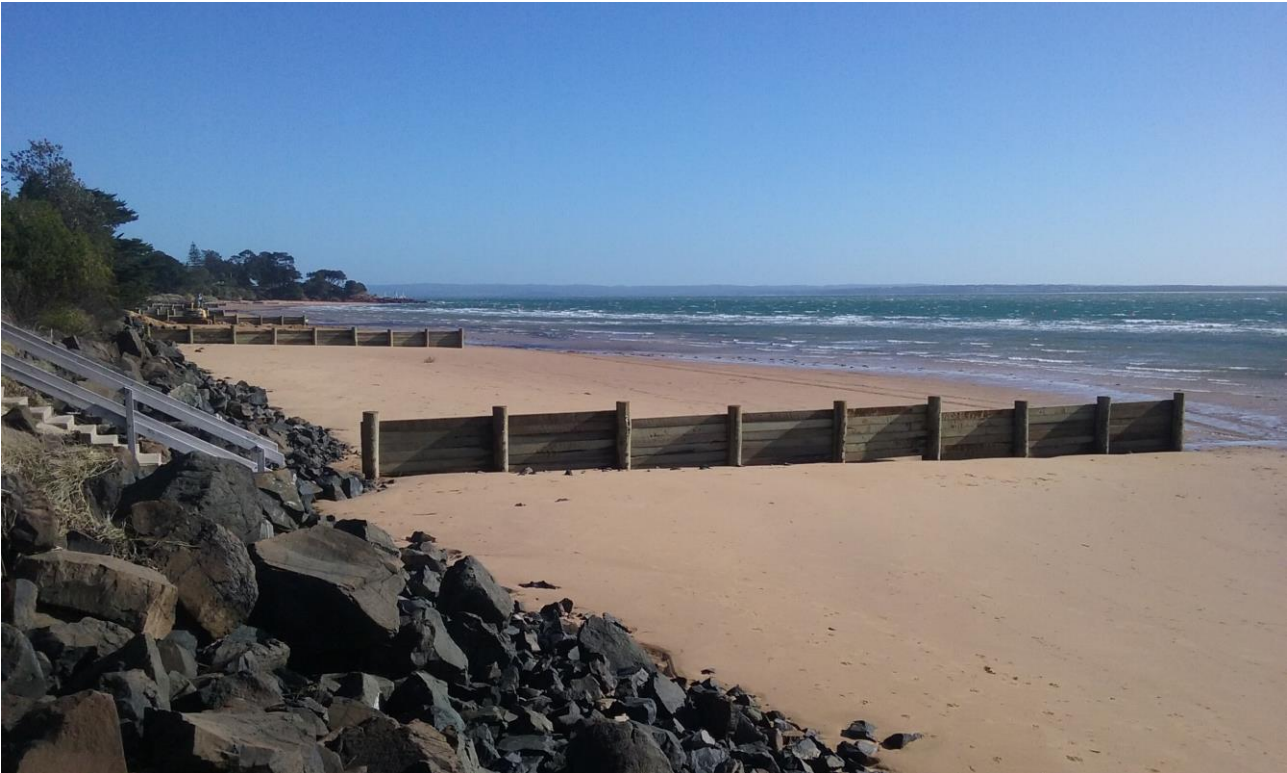
FIGURE 8-1 NEW GROUYNE STRUCTURES INSTALLED NEAR BROUGHTON AVE

Groynes do assist in maintaining beach levels and the associated recreational amenity of the study area. It is important to note though, that at the time any existing groynes are rebuilt, or new groynes installed the beach compartment to the west of the structure should be filled with sand, termed 'beach nourishment'. It is recommended that they not be allowed to fill by simply intercepting the natural longshore transport that prevails locally. This is because any sand that collects updrift (west) of a groyne to fill a beach compartment deprives the downdrift foreshore (east) of the trapped sand. This then accelerates erosion of the downdrift areas.

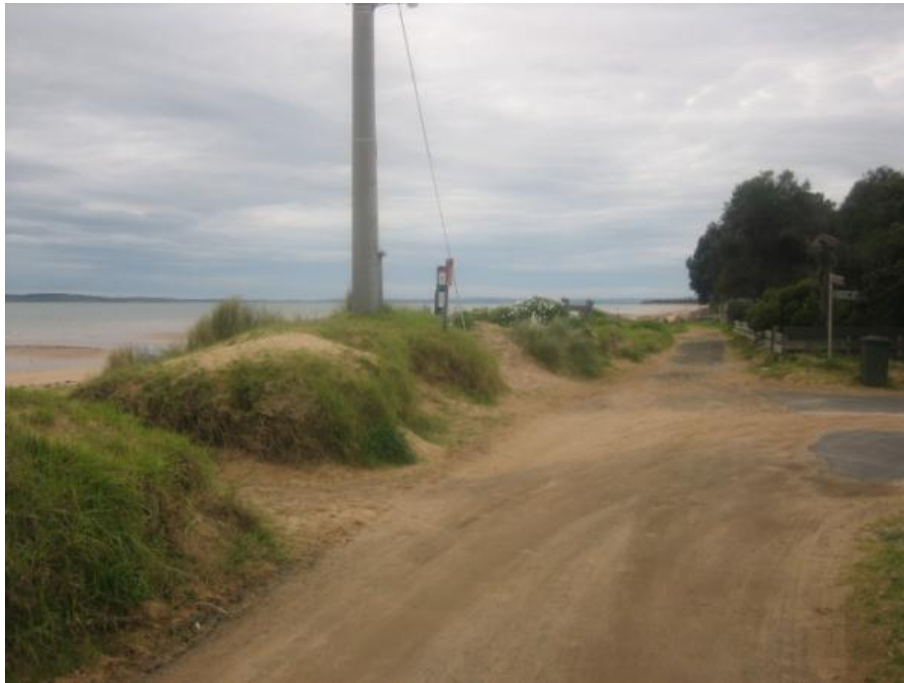
FIGURE 8-4 MULTIPLE BEACH ACCESS PATHS AND WIND-BLOWN SAND IMPACTS NEAR ROSE AVENUE
